LIGHT-INDUCED BIRD STRIKES ON VESSELS IN SOUTHWEST GREENLAND

TECHNICAL REPORT No. 84, 2010
PINNGORTITALERIFFIK
GREENLAND INSTITUTE OF NATURAL RESOURCES

Light-induced bird strikes on vessels in Southwest Greenland

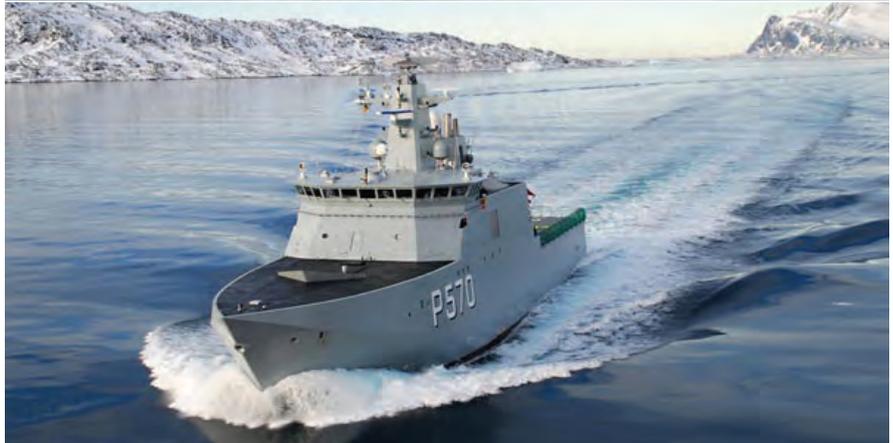
Fig. 2.2. Knud Rasmussen, a larger coastguard vessel. Photo: The Danish Navy

The use of light on vessels can serve multiple purposes and the quantity used depends on the type and the size of the vessel. In addition, ship construction varies quite a bit depending on the type of vessel (e.g., fig. 2.2 vs. fig. 2.4) and consequently the number of obstacles with which birds can collide varies considerably between vessels. Often spotlights are mounted above the bridge to illuminate the foredeck during factory operations. Such illumination should be shielded towards the sky, because birds are attracted primarily to light sources rather than the areas they illuminate (Reed *et al.* 1985). Further, the light disturbance could be much reduced if lights are turned off when foredeck activities are finished, especially when this coincide with poor visibility (fog or snow).
