Tusass Connect Marine Route Survey report

Seabed survey feasibility study in
Nuuk archipelago

Technical Report no. 126
Greenland Institute of Natural Resources

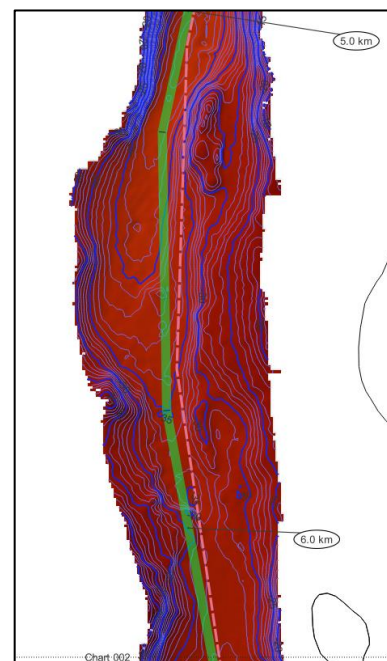
Figure 10: Detailed section of the narrow channel

The channel ends halfway between KP 06 and KP 07.

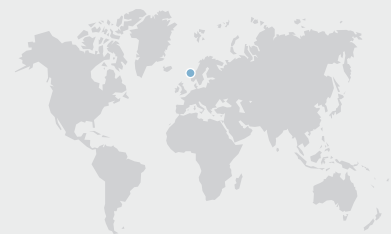
Survey equipment

Location of most important instruments

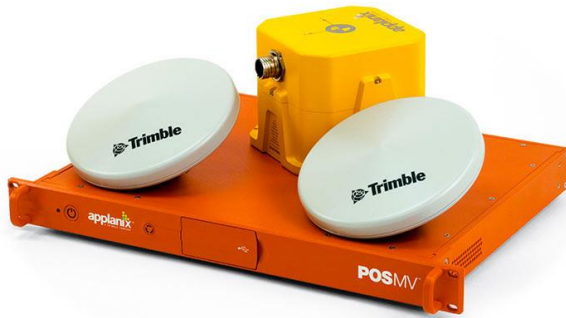
Manages GNSS position data, correction from base station data providers, IMU motion data, GNSS Azimuth Measurement System (GAMS) heading. Logging to files, and distribution via ethernet of data to SeabatUI, PDS2000 and Innomar SES-2000 (time tag, status, position, attitude, velocity, track, speed, dynamics, performance metrics, raw IMU, and raw GNSS data).

Post-processing of data in POSpac MMS8 as backup to Trimble CenterPoint RTX online corrections.

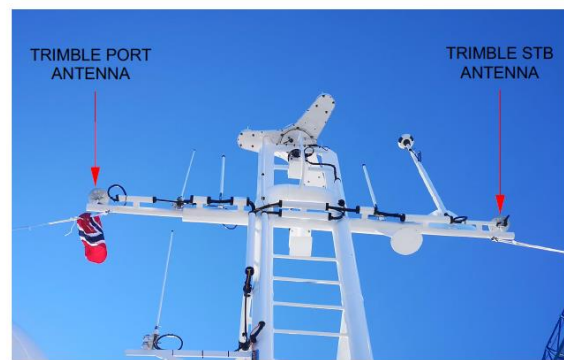
Figure 116: Trimble 540AP GNSS Antenna Footprint

TRIMBLE ANTENNAE
LOOKING FORWARD / UP

Trimble 540AP GNSS antenna, ANT1 40 starboard side, ANT1 41 port side

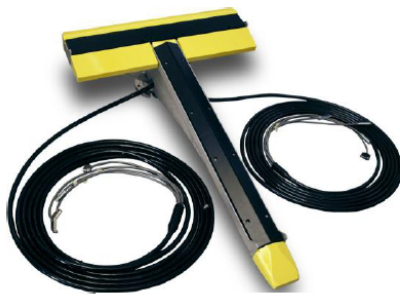
Figure 2: Sonar Head Assembly

The materials used are suitable for long-term immersion in sea water and are designed to withstand high-speed transits to and from survey areas and typical offshore sea conditions. Both arrays are sealed, self-contained units and contain minimal electronics encased in a protective coating. The receiver array contains wideband ceramic elements covering the frequency range of operation.

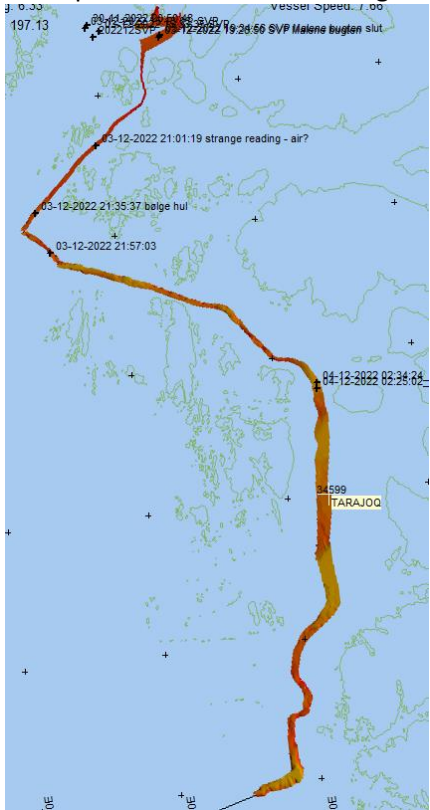
Position (Lat./Lon):	None recorded	None recorded	
Section:	Entire	Area name:	Nuuk skærgård
Overview chart insert:			
<p>Nuuk patch test area. Nuuk Ring route. Nuuk along Skærgårdsruten northern part to AC46.</p>

PROGRESS AND EVENTS	
SUMMARY OF WORK:	
Summary of the work performed during the preceding 24 hours	
<p>Start up on harbor. Inserting of newly calculated coordinate system values. Start from Nuuk at around 9:30/10:00 local time. Four runs on patch test slope, 6 and 12 knots. Result showed no offset and very good resolution. Further analysis displayed that we should take care of sharper turns, which produce offsets, apparently.</p> <p>Start of Nuuk Ring route from oil harbor (WP 0535) to Qinngorput (WP0451). Then along the coast near Qinngorput, then back to Nuuk harbor south of the route and then north of route.</p> <p>Cummulative swath of c. 700 m. Needs to be expanded with one or two lines more.</p> <p>Start on Nuuk Skærgårdsrute from WP0534 along center line to AC03, return for SVP between AC02 and AC03, continue to WP0534, turn and towards AC03.</p> <p>Then continue along the centerline.</p> <p>Swells/waves at AC10-AC14. Small gap at AC13</p> <p>PDS did not log without warning in a large stretch between AC25-AC26. The gap was filled after the incident was identified.</p> <p>Due to large waves/swells producing swells under the keel, survey towards south west stopped at AC45, returning at 2022-12-04 5:40 UTC on the eastern side of the main route.</p>
